# LEGACY MINING CONTAMINATION AND RENEWABLE ENERGY DEVELOPMENT IN QUEENSLAND

# AN ANALYSIS OF HISTORIC GOLD MINING CONTAMINATION CASES IN QUEENSLAND AUSTRALIA

# AN ANALYSIS OF HISTORIC MINING CONTAMINATION CASES: MOUNT MORGAN MINE – DEE RIVER

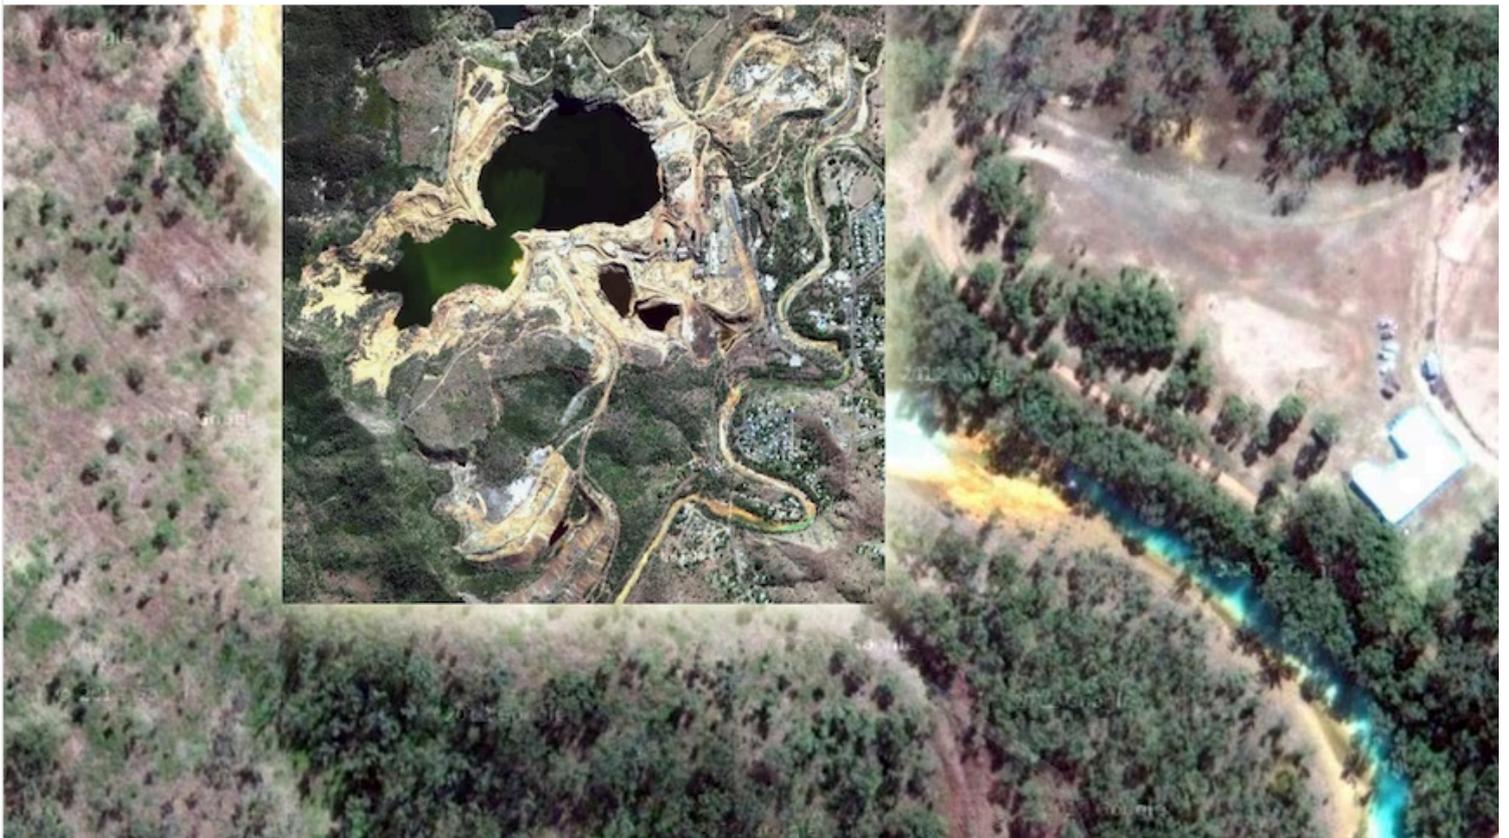
Google satellite imagery of the Dee River near Mount Morgan, turned aquamarine by waste water contaminants. Locals say that since ex-cyclone Oswald the pollution has stretched even further down stream.

- **Acid Mine Drainage (AMD):** When the mine closed, large amounts of sulfide minerals were exposed to air and water, producing sulfuric acid. This acid then leached heavy metals such as arsenic, cadmium, and lead into the Dee River.
- **Water Quality:** The Dee River's water quality has been severely affected, making it unsuitable for agricultural and recreational use.
- **Remediation Efforts:** The Queensland Government has undertaken various remediation projects, including water treatment plants and containment of contaminated materials, but challenges remain.

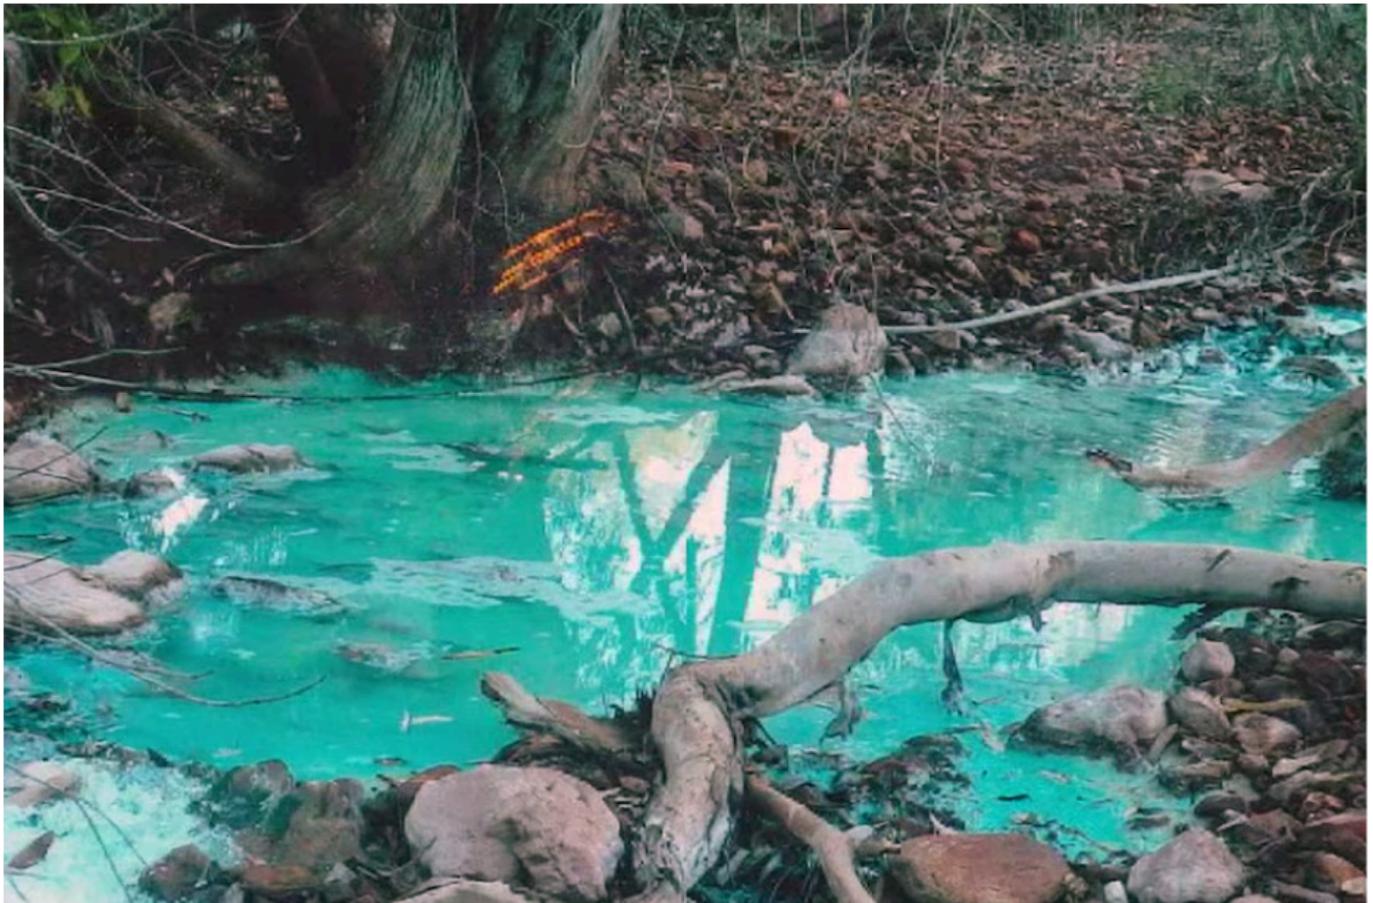
After rain, rivers around the Mt Oxide mine turned sky blue. River near the Mount Oxide copper mine, north of Mount Isa, which turned blue. The Mount Oxide mine was abandoned in 1971. (Supplied)
